TANK WARFARE

ARMORED COMBAT IN THE NORMANDY CAMPAIGN JUNE-AUGUST 1944

Steven J. Zaloga and George Balin

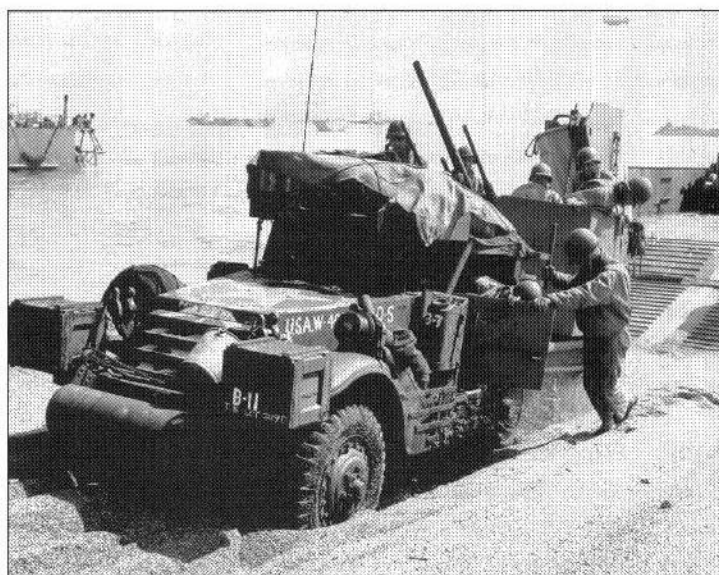
A M15A1 CGMC anti-aircraft vehicle is stuck in the soft beach sand at Slapton Sands on the English coast on 27 April 1944 during invasion exercises. The Slapton Sands exercise area was the scene of a controversial incident prior to the invasion when German E-boats managed to sink a troop-laden cargo ship, leading to heavy losses amongst the US infantry on-board. The incident was officially censored in 1944 for fear of revealing information about the forthcoming invasion, and became the source of controversy in the 1980s when relatives of the infantrymen lost in the incident tried to learn more details of the disaster. (US Army)

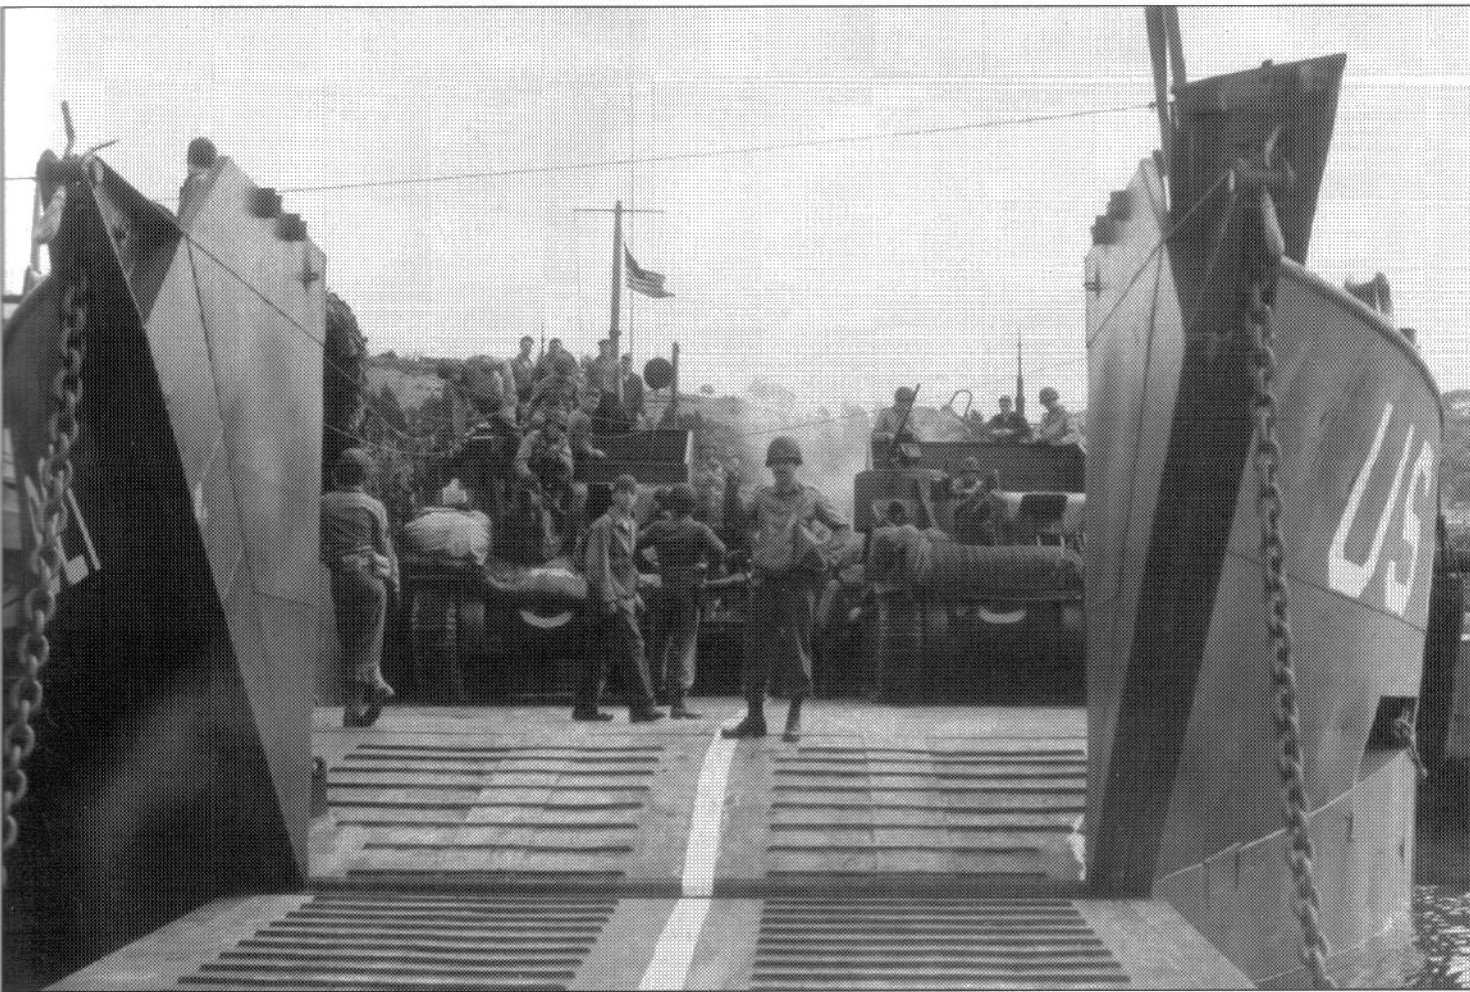
Four M10 3 inch tank destroyers are loaded aboard an LCT Mark 6, probably in Weymouth or Torquay harbor, in early June 1944. Each LCT could carry four medium tanks or their equivalents. These were the most common landing craft used in the initial assaults, with follow up landings conducted with the larger LSTs. Many of the LCTs delivering US tank units to the beaches on D-Day were manned by Royal Navy crews. (US Army)

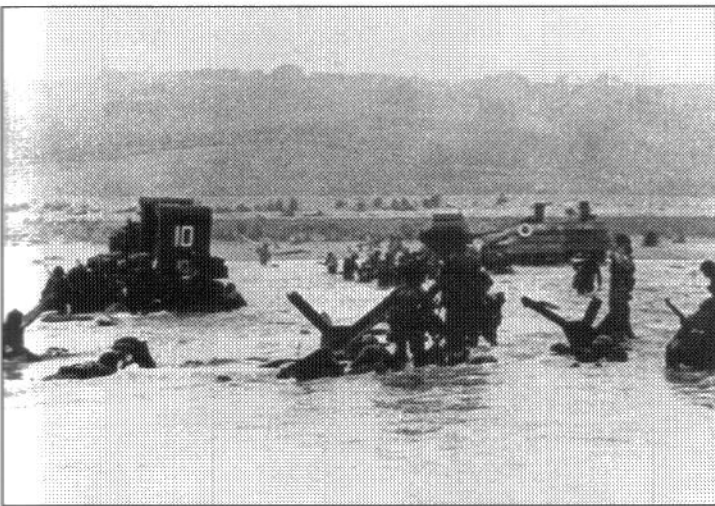
Few photos survive of the Omaha beach landings. Here is a rare shot from the morning of 6 June at Omaha beach with a M4 with deep wading trunks to the left and a M4 Duplex Drive to the right from the 741st or 743rd Tank Bn. The high escarpment that trapped the US forces on Omaha is very evident in this view. Many of the 96 tanks landed at Omaha beach were knocked out by German anti-tank guns placed in bunkers along the beach or along the escarpment. (The Tank Museum)

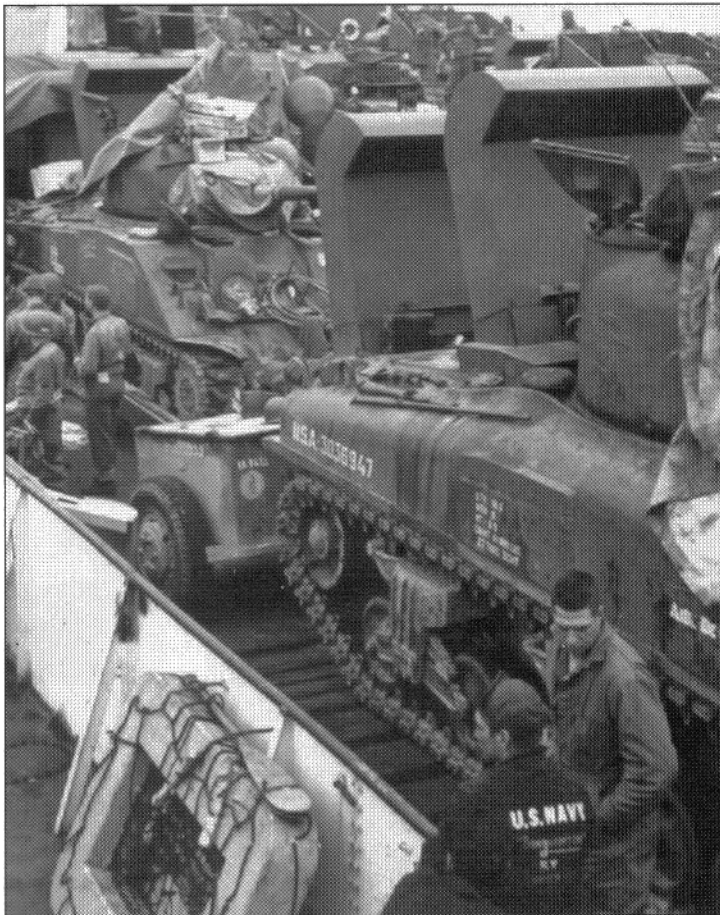
A pair of M4 medium tanks of A Company, 741st Tank Battalion on their LCTs in harbor in Britain prior to embarking to France for the landing at Normandy. These tanks were part of the first wave of four LCTs that landed on Omaha beach on D-Day. Most of the tanks were quickly knocked out by German gun emplacements. (US Army)

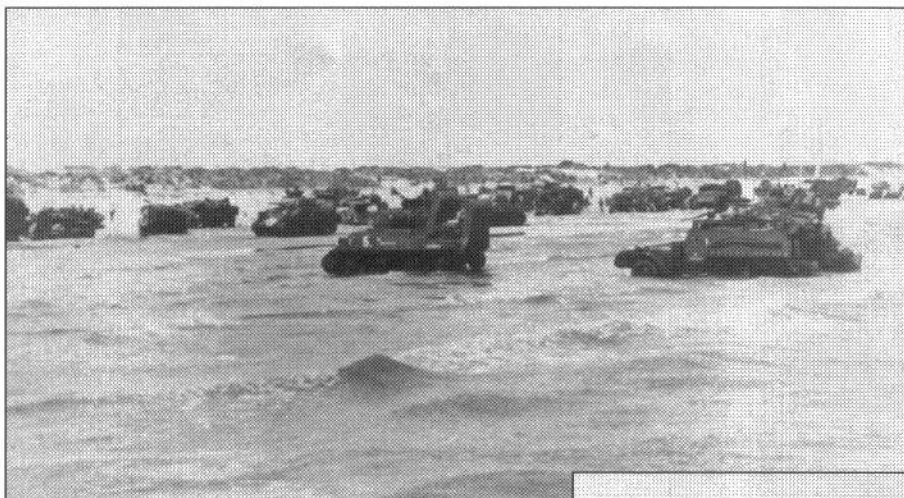
The situation at Utah beach was not as desperate as at Omaha. Here, Company C of the 70th Tank Bn. lands with their M4s, fitted with deep wading trunks. In contrast to Omaha beach, notice the lack of a high escarpment beyond the beach, a geographic detail which greatly effected the course of the fighting. (US Army)

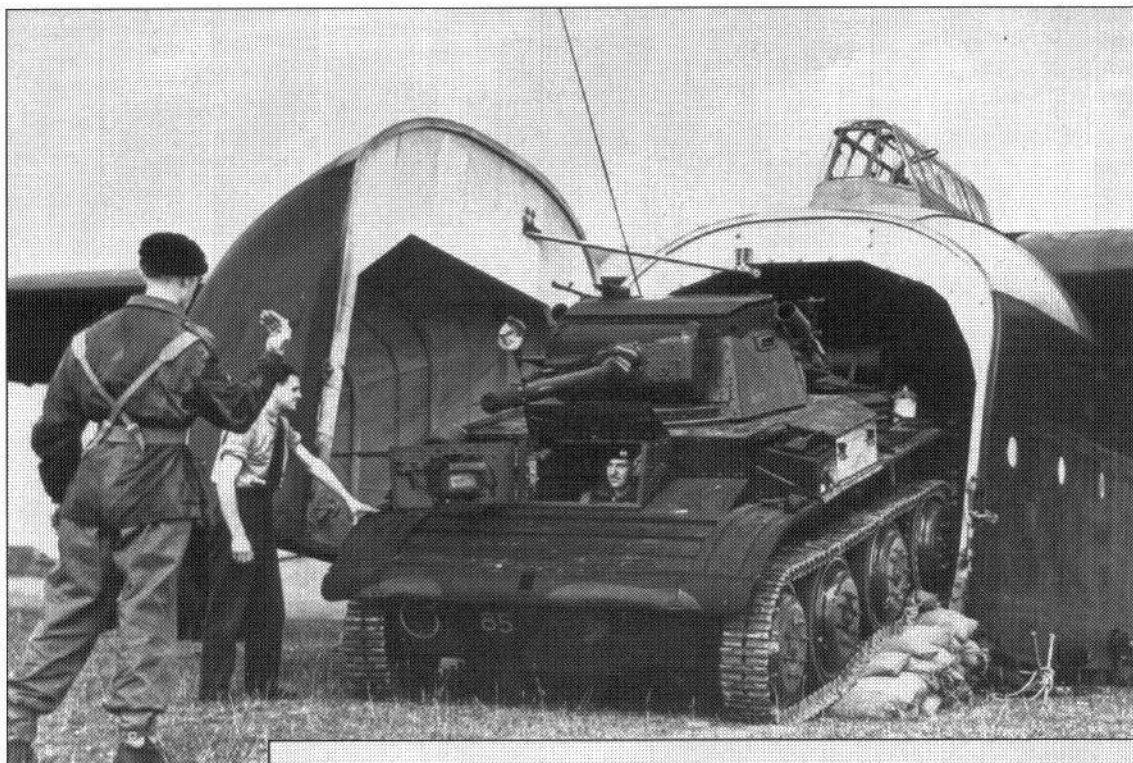
One of the most curious tanks taking part during D-Day were the eight Tetrarch light airborne tanks of the British 6th Airborne Recce Regt., 6th Airborne Division which landed in the second wave on the evening of D-Day on Hamilcar gliders to help the paratroopers seize the Orne river crossings. This is "Ritz", a Tetrarch Mk. 1CS of the HQ section, which was armed with a 3 inch gun for close support instead of the usual 2 pdr. This photo was taken during training prior to the landings. The Tetrarchs were not very effective during the operation, as their suspensions tended to become ensnared by the tough nylon parachute suspension lines that littered the landing zone. They were later replaced with Cromwell tanks. (The Tank Museum)

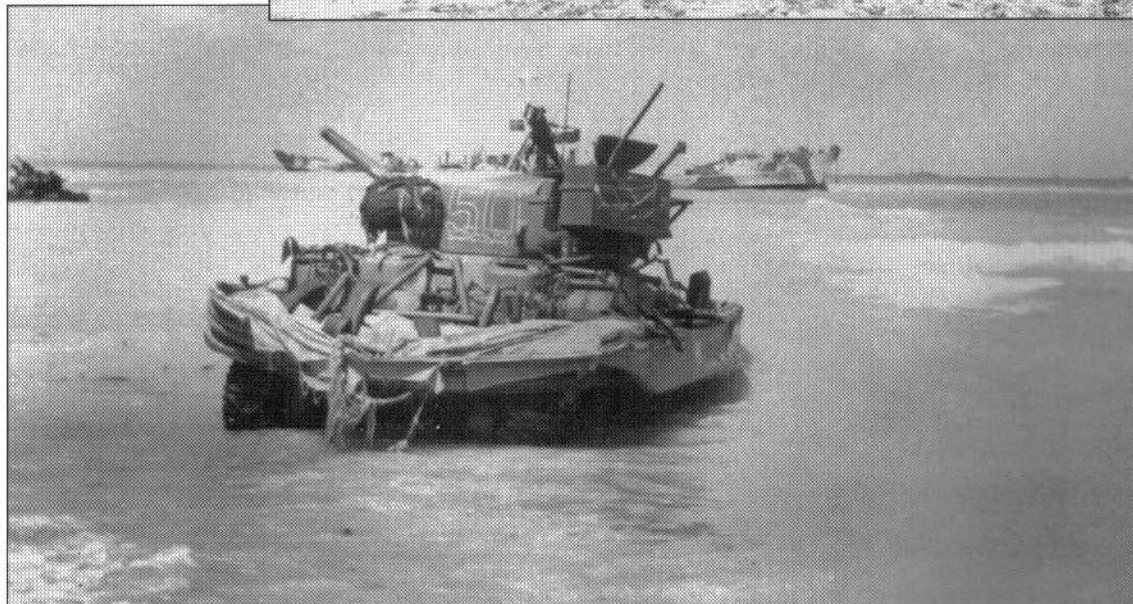
This Sherman II Duplex Drive of the 13/18th Hussars almost made it all the way to shore on D-Day, but got stopped short at Sword Beach. The Duplex Drive consisted of a canvas skirt around the tank which made it bouyant, combined with a pair of propellers at the rear for propulsion. In this view, the screens are collapsed, showing the rubber inner tubes that helped keep the swimming skin erect. This tank is marked with a large white Allied star on the turret roof, and large, two-digit tactical numbers on the turret side. (The Tank Museum)

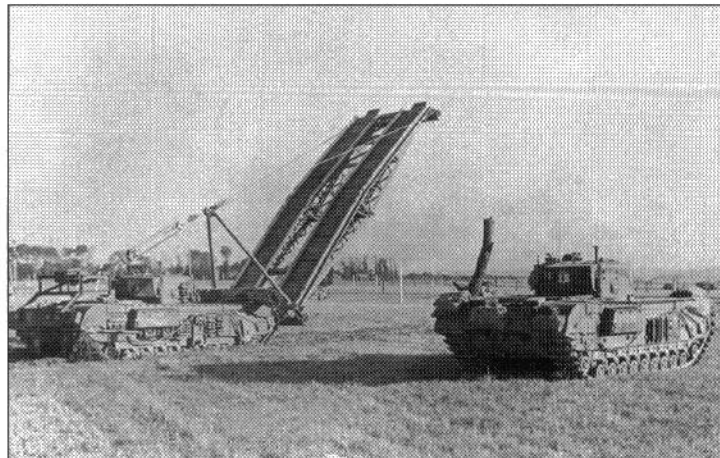
A view of a Churchill AVRE of the 222 Assault Sqd., 42nd Assault Regt., 79th Arm'd Division with the SBG fitted at the front. The SBG was designed to cover anti-tank ditches or other beach obstructions; a small roll of fascines was carried at the front of the tank that was dropped at the lip of the SBG to help tanks mount it. This photo was taken in September 1944 when the Funnies were supporting operations near Le Havre. (The Tank Museum)

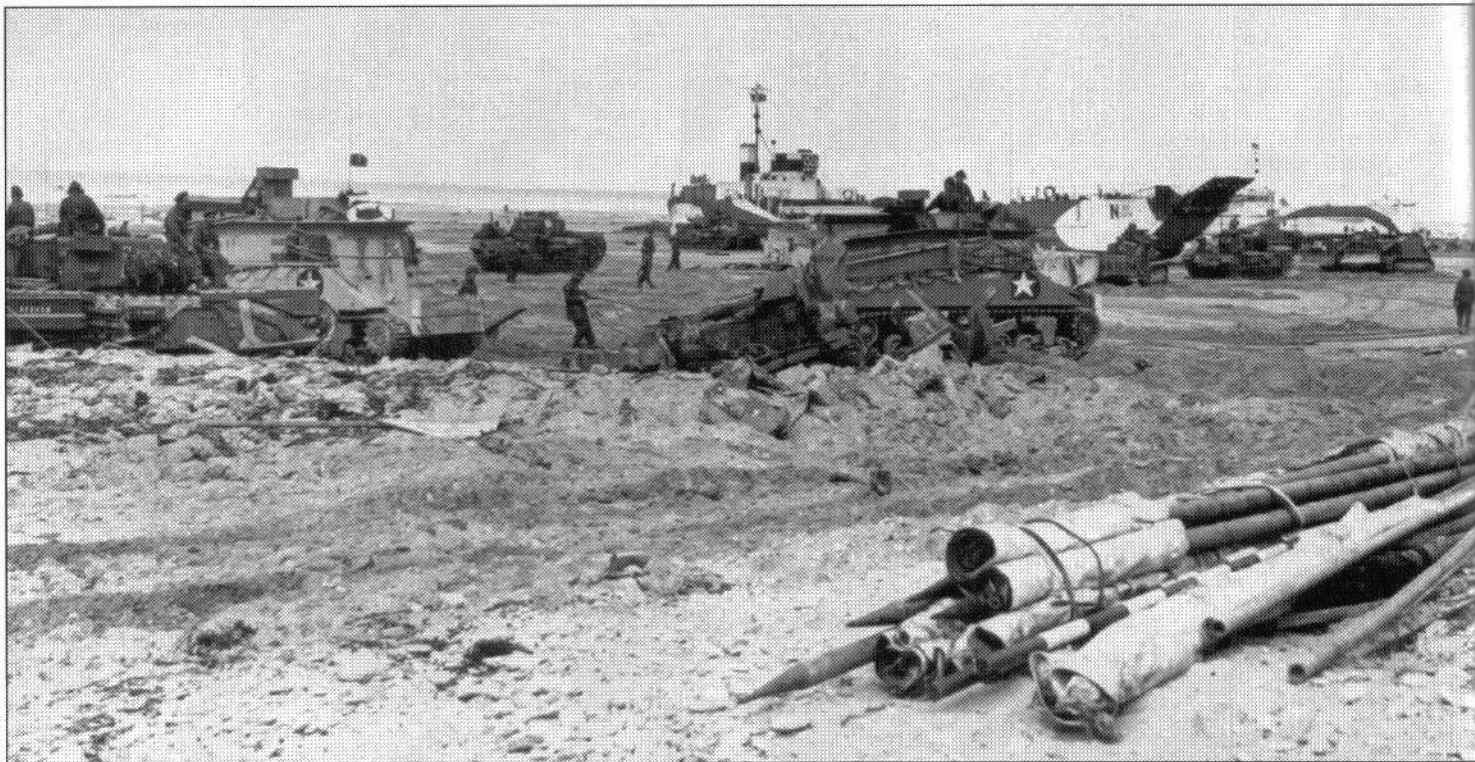
Clean-up activity goes on at one of the British beaches after the landing. The two armored vehicles with prominent white stars are Sherman BARV (Beach Armoured Recovery Vehicles), an interesting British innovation based on the M4 medium tank chassis. A large watertight superstructure was built on the chassis, which allowed the vehicle to operate in the surf to recover disabled tanks and other vehicles. (The Tank Museum)

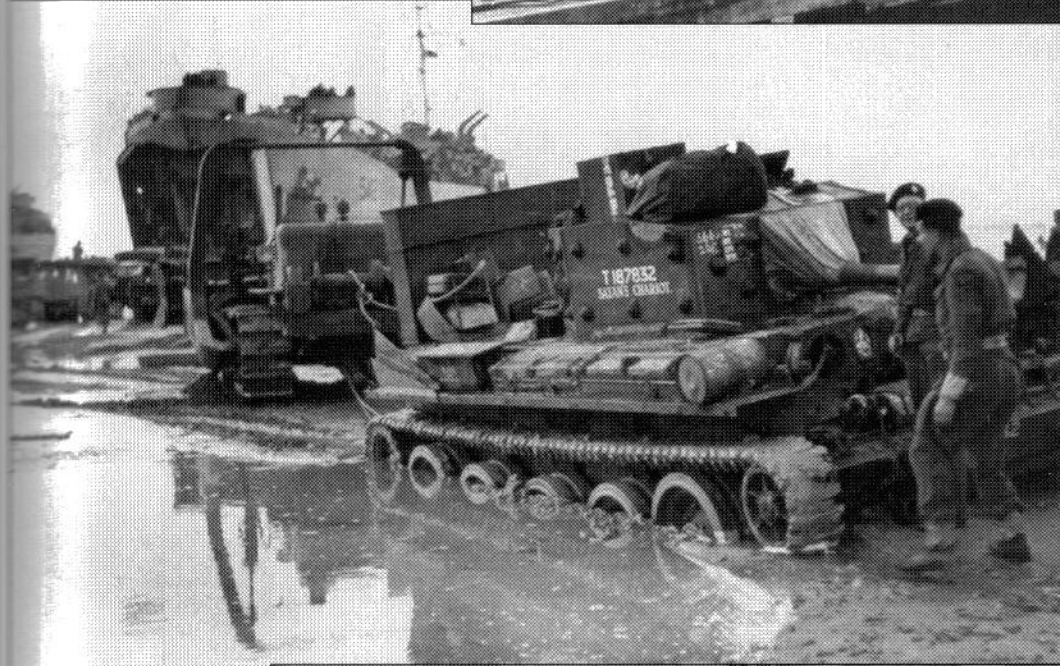
A Cromwell tank named "Satan's Chariot" of the 5 RTR, 7th Armoured Div. bogged down at Gold Beach is recovered by a bulldozer while a LST unloads in the background. This vehicle is fitted with the seldom-seen deep wading trunks used on Cromwells and related cruiser tanks. The 7th Armoured Division was the main armored component of the follow-on forces, landing on 9 June to reinforce the British XXX Corps. (The Tank Museum)

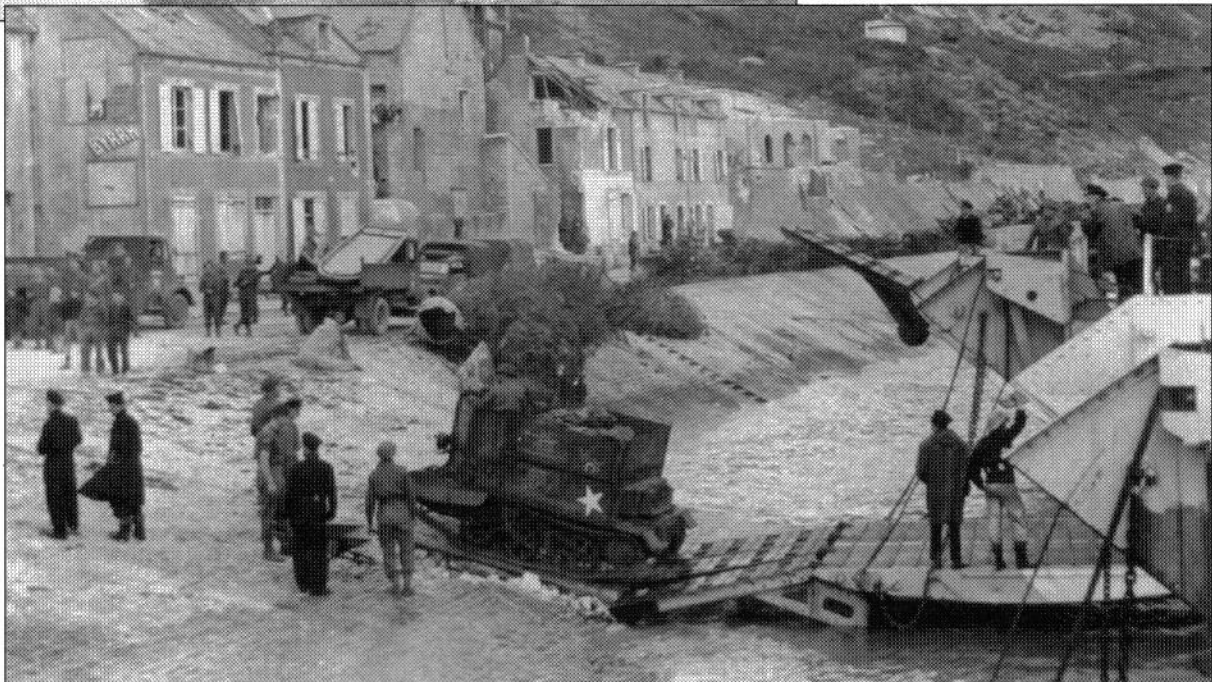
A Deep Wading Universal Carrier comes ashore directly on the beach at high tide from a LCT. Because the Universal Carrier was so low to the ground, a very extensive combing had to be added around the superstructure to allow it to wade in through the surf. The Universal Carrier was the standard infantry vehicle of the British Army in Normandy, but after the July fighting, attempts were made to develop better protected vehicle. (The Tank Museum)

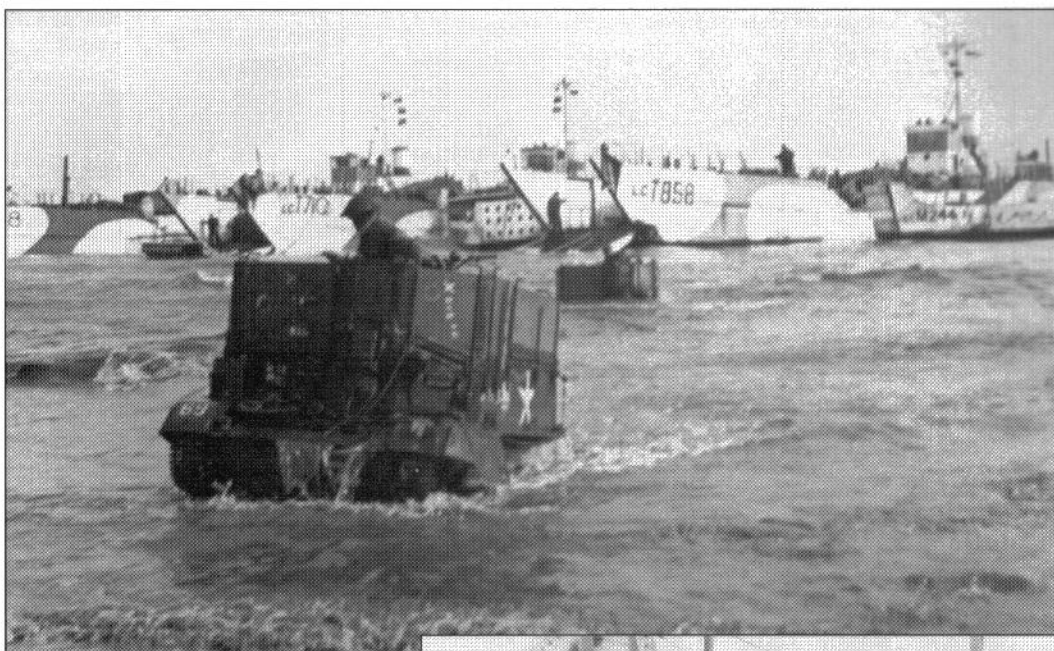
A pair of Universal Carriers of the 50th Northumbrian Division come ashore at Sword Beach from the LCTs behind them. This gives a good idea of why the extensive combing had to be added around the superstructure. (The Tank Museum)

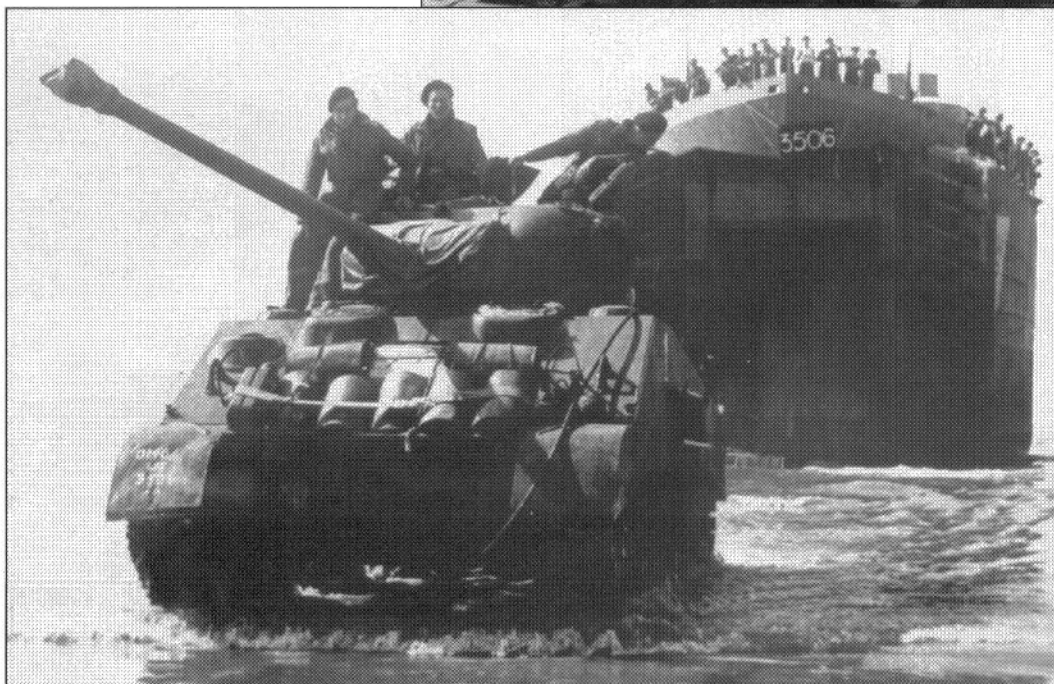
One of the most important innovations in the British armoured divisions was the Sherman Firefly tank, armed with the 17 pdr. This was the only Allied tank able to deal frontally with the heavily armored German tanks like the Panther and Tiger. They were usually issued on a scale of one per troop (one per four tanks) in British, Canadian, and Polish divisions. (The Tank Museum)

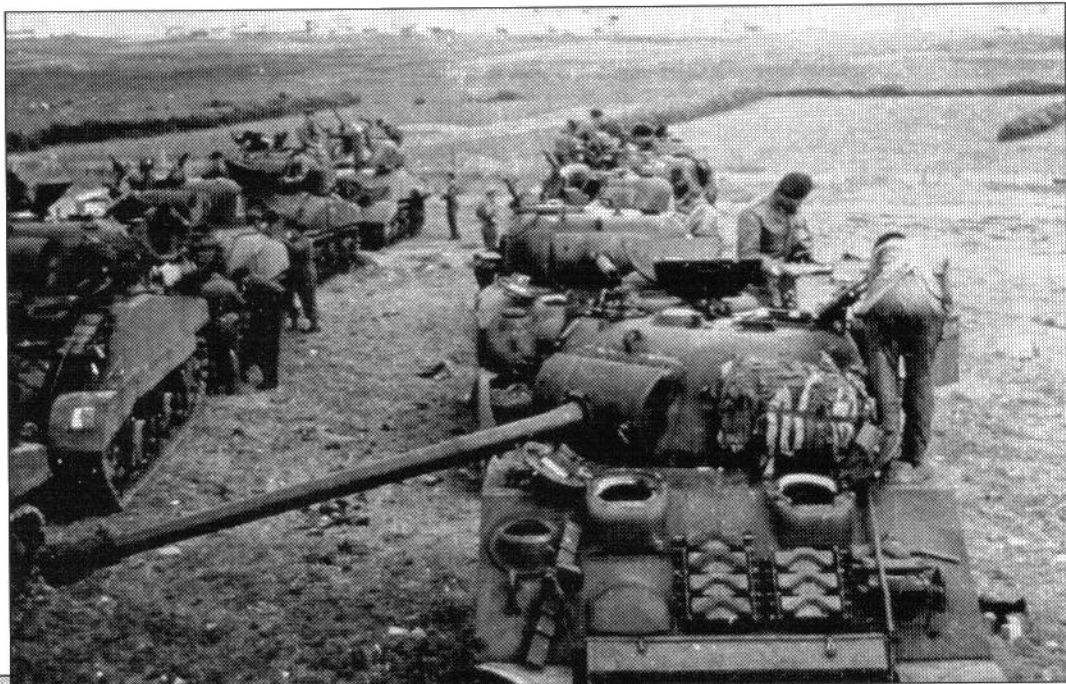
Tankers of the British 4th Armoured Bde., 7th Arm'd Div. prepare their tanks for combat in the fields immediately beyond Gold Beach; the landing area is still evident in the background. The lead vehicle is a Sherman Vc Firefly while the tank behind it is a Sherman II armed with the normal 75mm gun. To accomodate enough ammunition, the Firefly conversion dispensed with the bow machine gun, and careful inspection of the right side of the hull front will reveal that the machine gun position is plated over. (The Tank Museum)

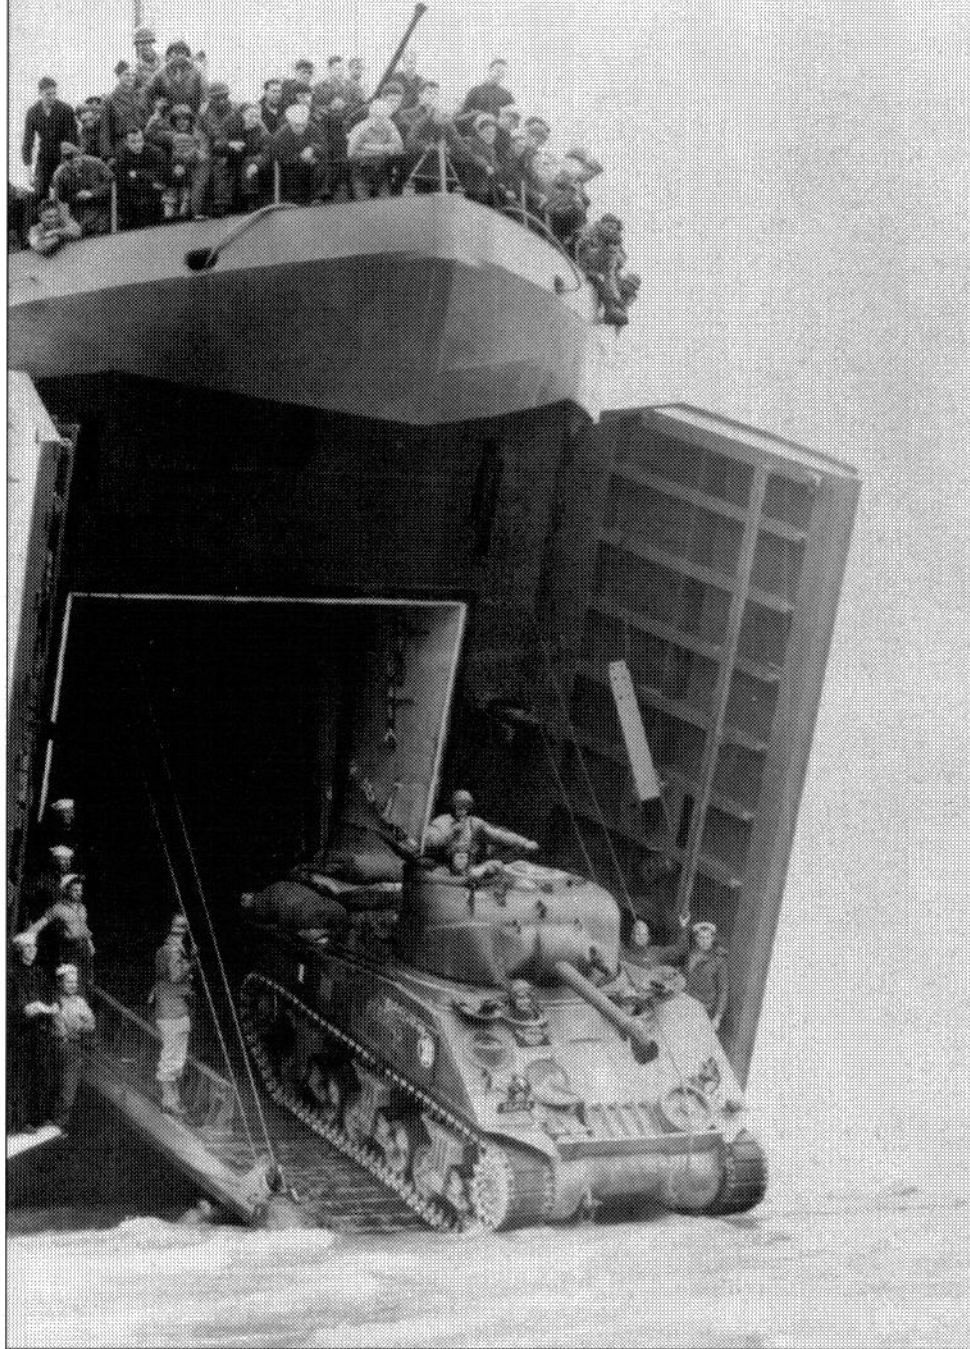
Another of the tank units landed to assist in the breakout operations was the French 2nd Armored Division, which landed at Utah Beach on 1 August. This is a M4A2 tank named "Pertrous" from the 12e Regiment de Chasseurs d'Afrique. Careful inspection of the right headlight framing will reveal a "SOMUA" plate, a reminder that many of these tank crews had served on a SOMUA 35.S tank when first stationed in French North Africa. (US Army)

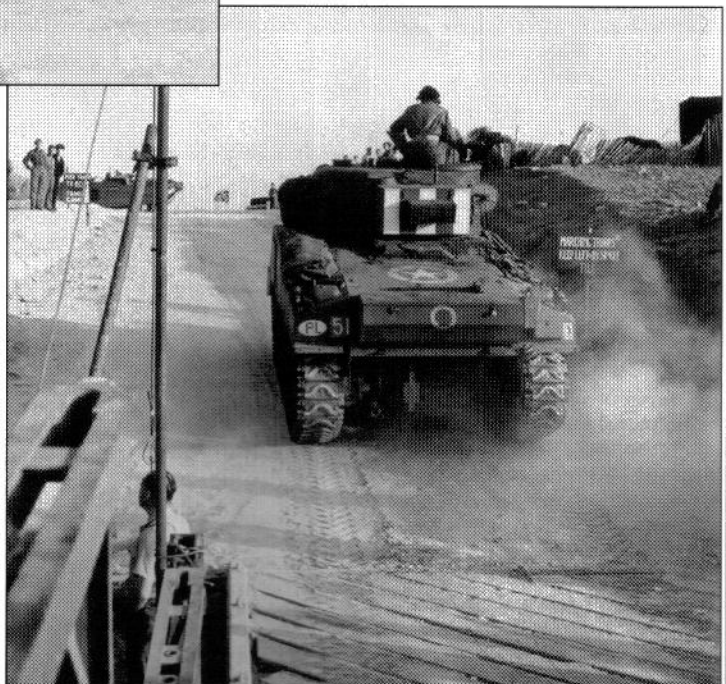
Once free of the beaches, the Duplex Drive Shermans shed their swimming skirts, as we see on this column of British Shermans passing through Douet. The DD tanks often retained the metal framing for the skirts, making them identifiable even with the skirts removed. (The Tank Museum)

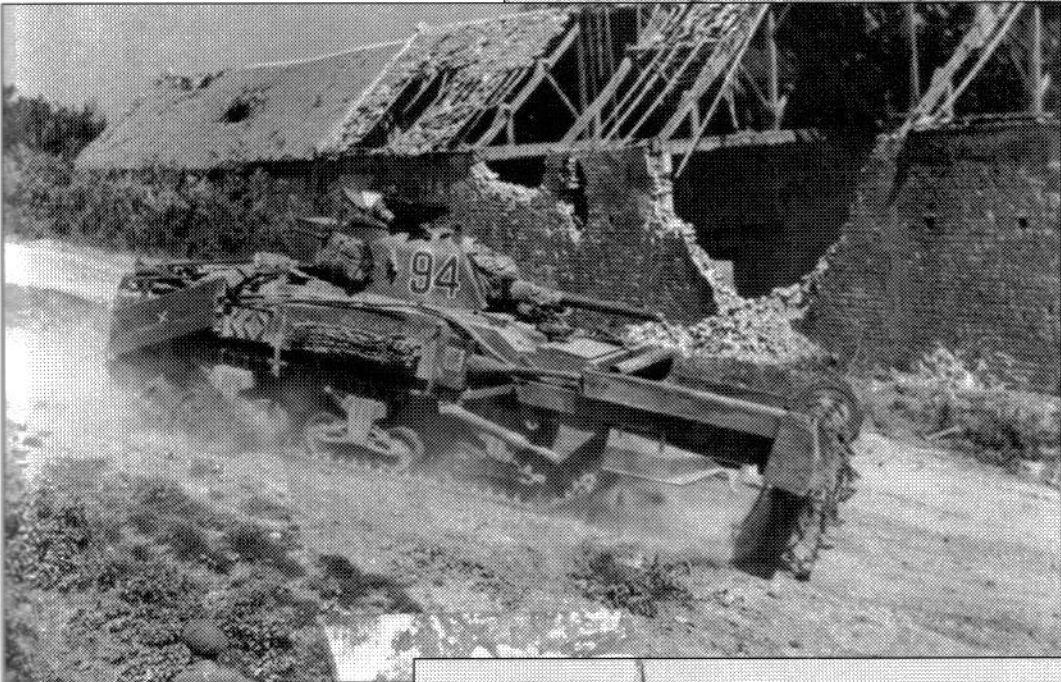
The Sherman Crab was another British innovation that was widely used during the Normandy operation. The Crab was another Sherman engineer modification with a mine flail attached at the front. The large structure continued the powertrain which spun the flail chains in front of the tank which detonated mines. The device at the rear of the tank dropped lane markers to identify cleared areas. British flail tanks had been employed since the North African campaign and continually refined. (The Tank Museum)

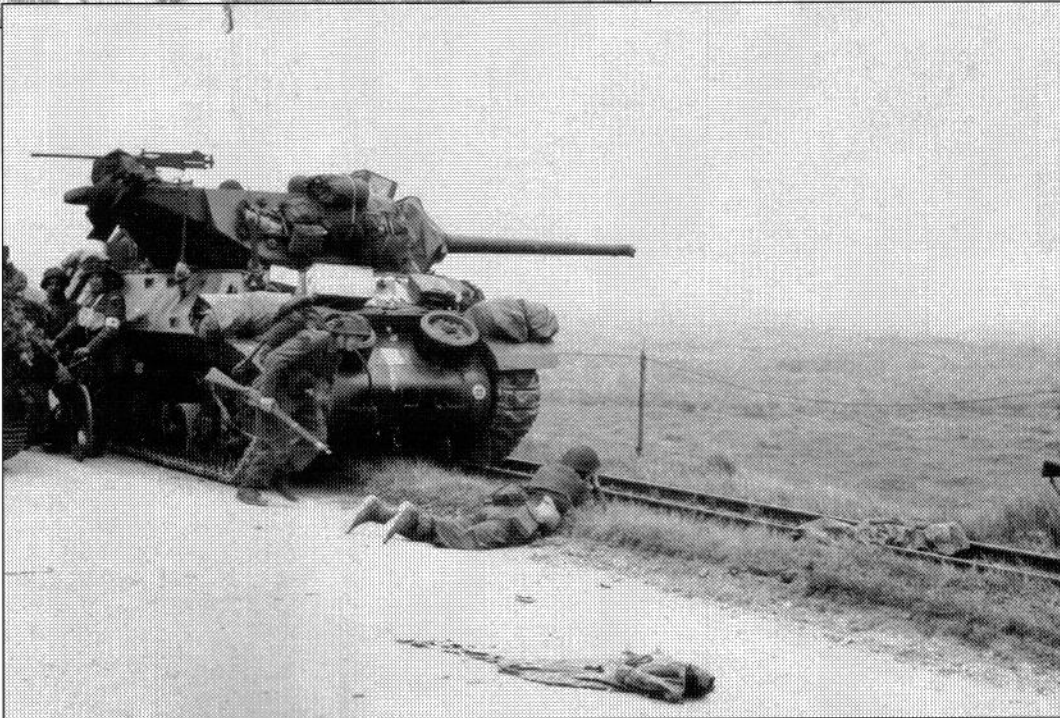
A M10 Achilles Mk. II engages German snipers while supporting 3rd Division infantry in early June in the area beyond Sword beach. The Achilles was the British name for the American M10 tank destroyer; the Mk. I was the early version with the triangular rear turret counter-weights, the Mk. II referred to the enlarged turret with the "duck-bill" counterweights at the rear of the turret. (The Tank Museum)

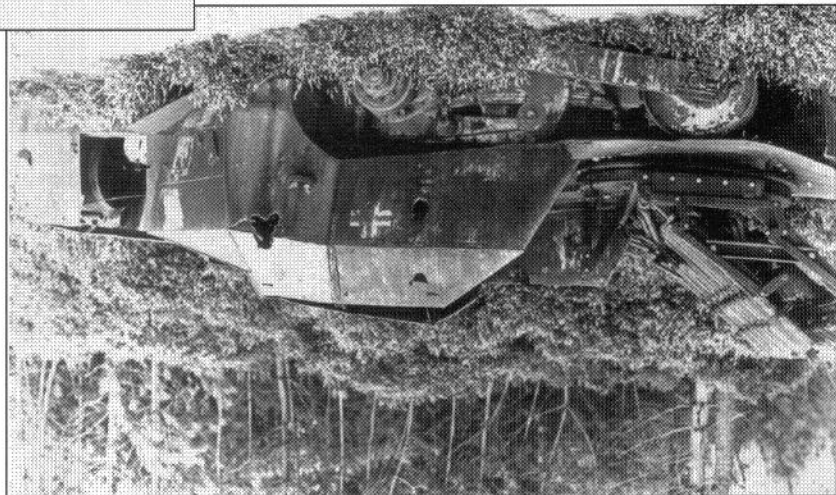
One of the most characteristic sights in the early Normandy fighting were a variety of bizarre armored vehicles based on French and British armored vehicles captured in the 1940 Battle of France. These brainchild of Alfred Becker, an artillery officer who served in the German artillery in France in 1940. Because of his family's industrial contacts back in Germany, Becker managed to have many captured vehicles shipped back to Alkett in Berlin-Spandau where they were rebuilt as self-propelled artillery. This unusual vehicle is a 20-barrel 81mm mortar rig mounted on an armoured SOMUA MCG S 307(f) half-track. A similar mounting was also made on the SOMUA MCL half-track. (US National Archives, Federal Records Center-Suitland)

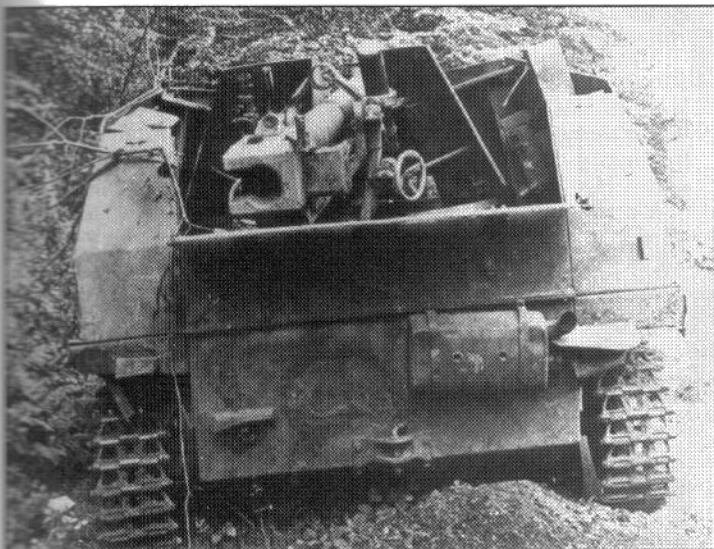
Fire support for the panzer divisions was provided by the Sd.Kfz. 124, popularly called the Wespe. This was a 105mm howitzer on the obsolete Pz.Kpfw. II chassis. This Wespe knocked out in Normandy has its entire recuperator assembly over the gun barrel missing; whether from combat damage or Allied action is not clear. (US National Archives, Federal Records Center-Suitland)

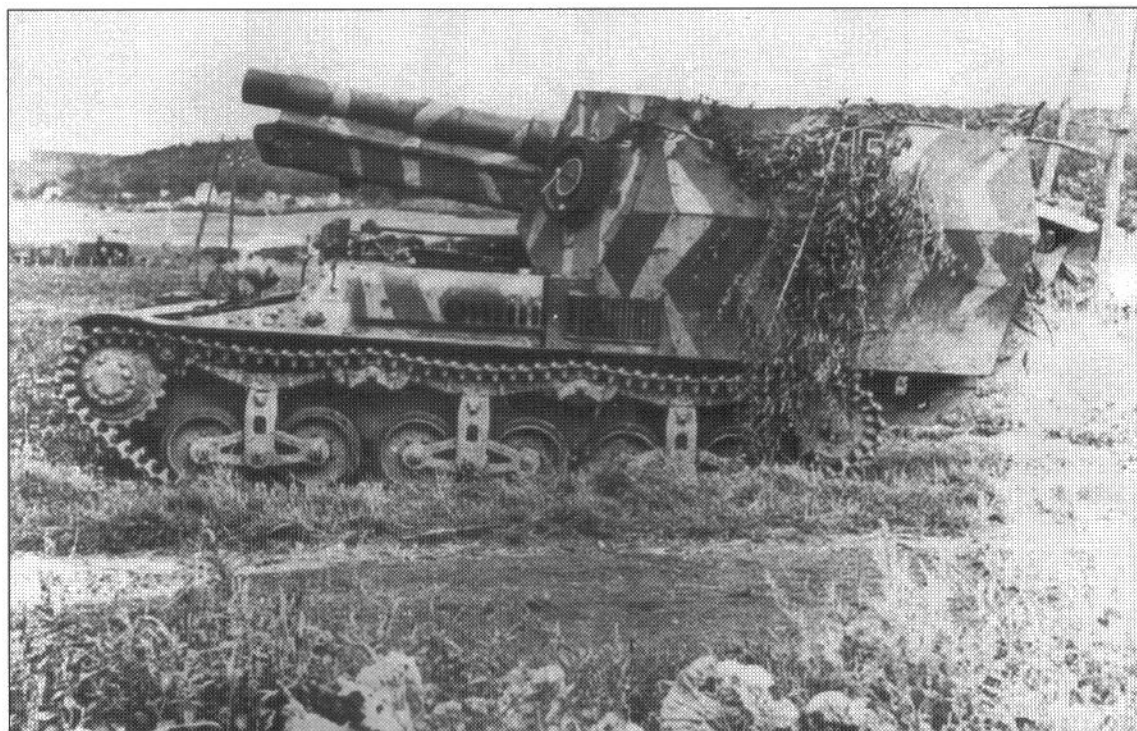
One of the more widely traveled of the Becker conversions was the 15 cm-sFH 13/1 auf Geschutzwagen Lorraine-S (f) Sd.Kfz. 135/1 which consisted of a German World War I-vintage 150mm field howitzer mounted on a French Chenillette Lorraine armored transporter. A total of 72 of these were built by the Baukommando Becker in Paris, and some served with 21. Pz.Div. in the North African campaign. In 1943, the survivors equipped the "Verstärkten Schnellen Brigade West" and in the summer of 1944, 45 were attached to the Pz.Art.Rgt. 155 of 21.Pz.Div. along with 43 similar conversions on Hotchkiss light tank chassis. This vehicle, captured by the US Army, has a particularly elaborate splinter camouflage. (US Army)

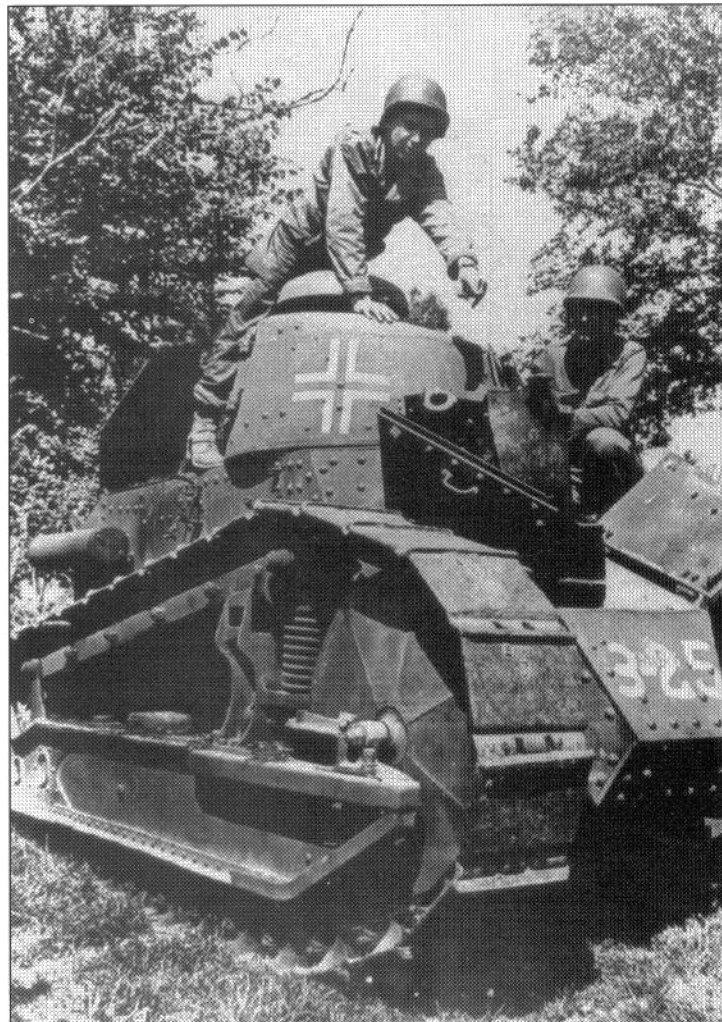
During the Normandy fighting, a number of old World War I-vintage Renault FT light tanks were encountered by Allied forces. These were used by German tank units for training duties, and in German security units for police actions and guard duty. The Luftwaffe also used the old tanks around airfields, both for runway security and for towing. Many FT turrets were cannibalized from non-functioning chassis, and employed on concrete shore bunkers along the Normandy coast. (US Army)

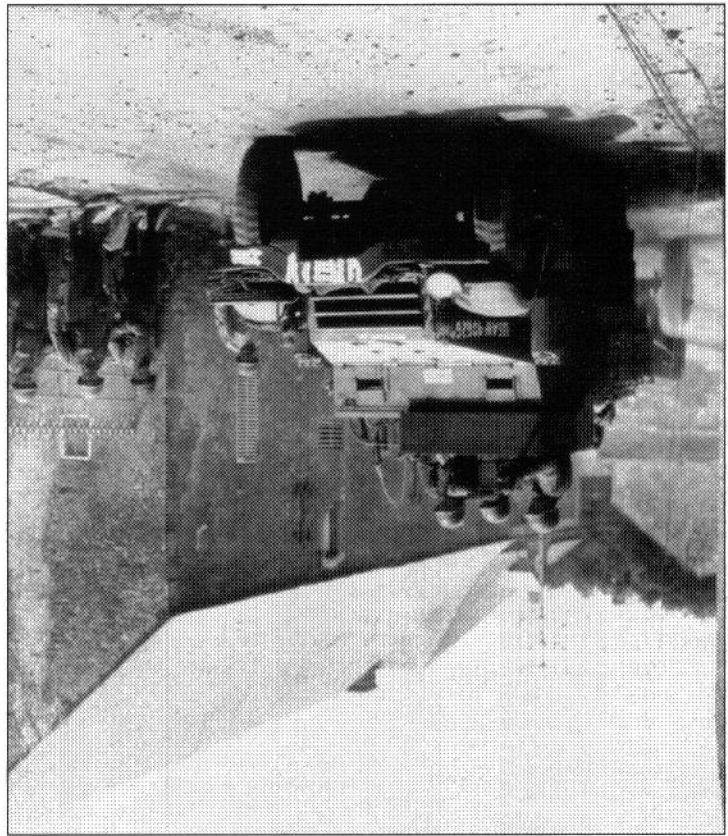
A US Army M3A1 half-track personnel carrier belonging to a tank destroyer battalion drives through a French village in Normandy on the way to the front. The M3A1 half-track was the standard US Army armored infantry transporter during the campaign, and was widely used in other roles as seen here. Careful inspection of the photo will reveal that it is towing a M3 76mm anti-tank gun, a towed version of the weapon on the M10 tank destroyer. These towed tank destroyer battalions were not particularly successful due to the lack of mobility and weak protection of their gun crews, compared to the self-propelled battalions. As in many official photos from the summer of 1944, the censor has blotted out the unit bumper codes on the photo for security reasons. (US Army)

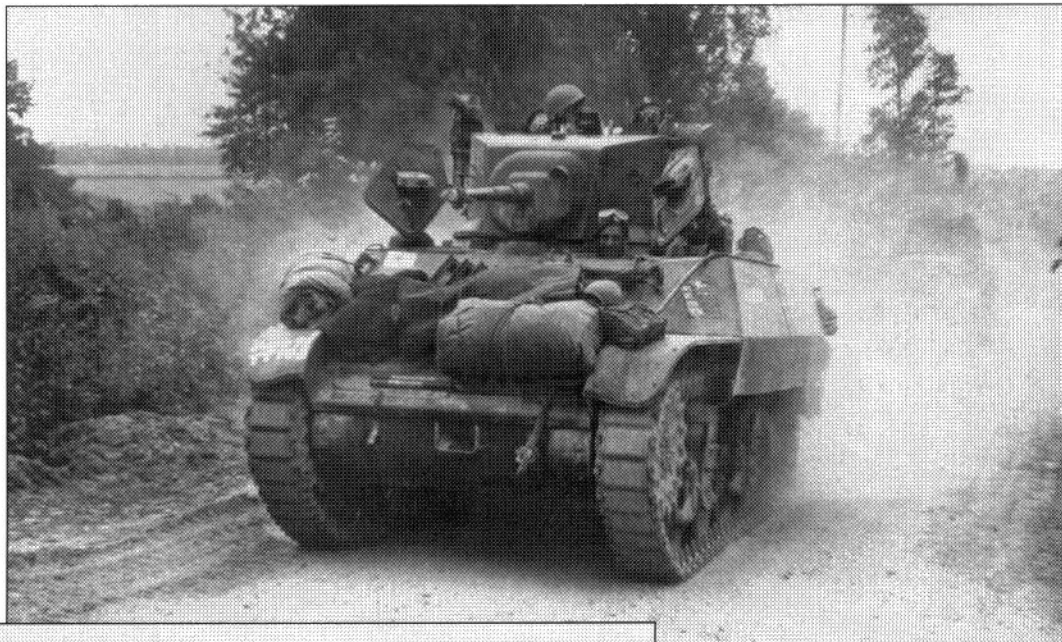
The standard recon tank in the British armoured divisions in Normandy was the Stuart V (M3A3), seen in action on 15 June near Bayeux-Tilly with the 7th Armoured Division. The division's legendary Desert Rat insignia can be barely seen on the upper right corner of the glacis plate in front of the co-driver position. Although automotively improved over the Stuart versions used in North Africa, its firepower was no better. (The Tank Museum)

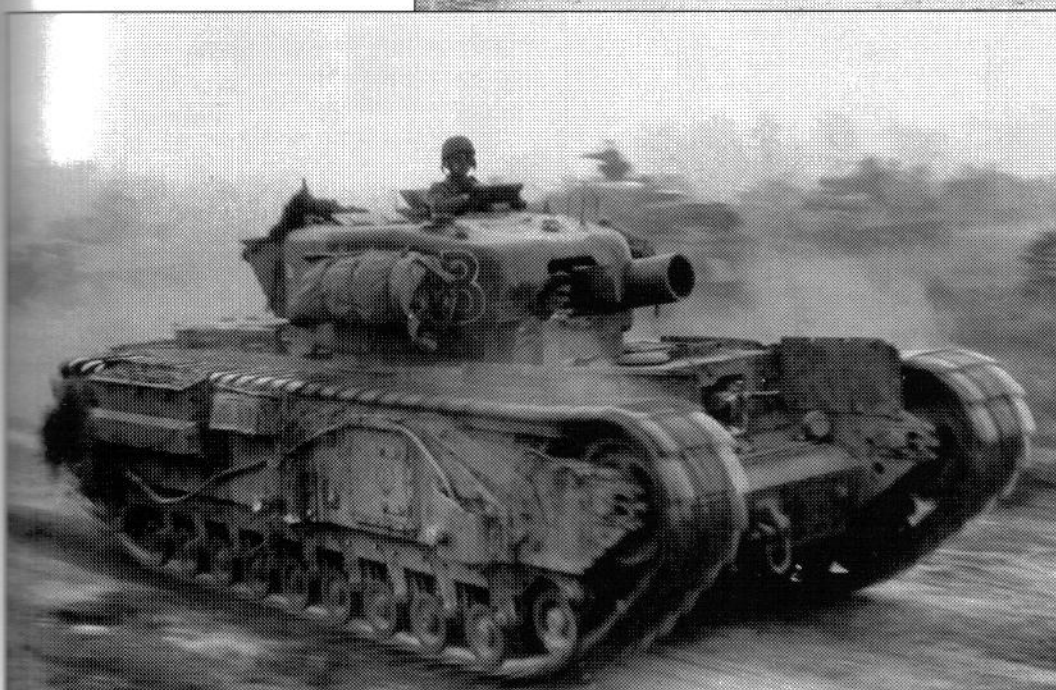
A Churchill IV AVRE barreling along a road in Normandy. The AVRE version of the Churchill is easily distinguished by the enormous bore of the Petard launcher mounted on the turret front. The Churchill was generally popular in the British tank brigades because of its thick armor, but it was slow and underpowered compared to other Allied tanks. Unlike the Sherman, none were upgunned with the 17 pdr., which limited the effectiveness of Churchills in tank-vs.-tank combat. (The Tank Museum)

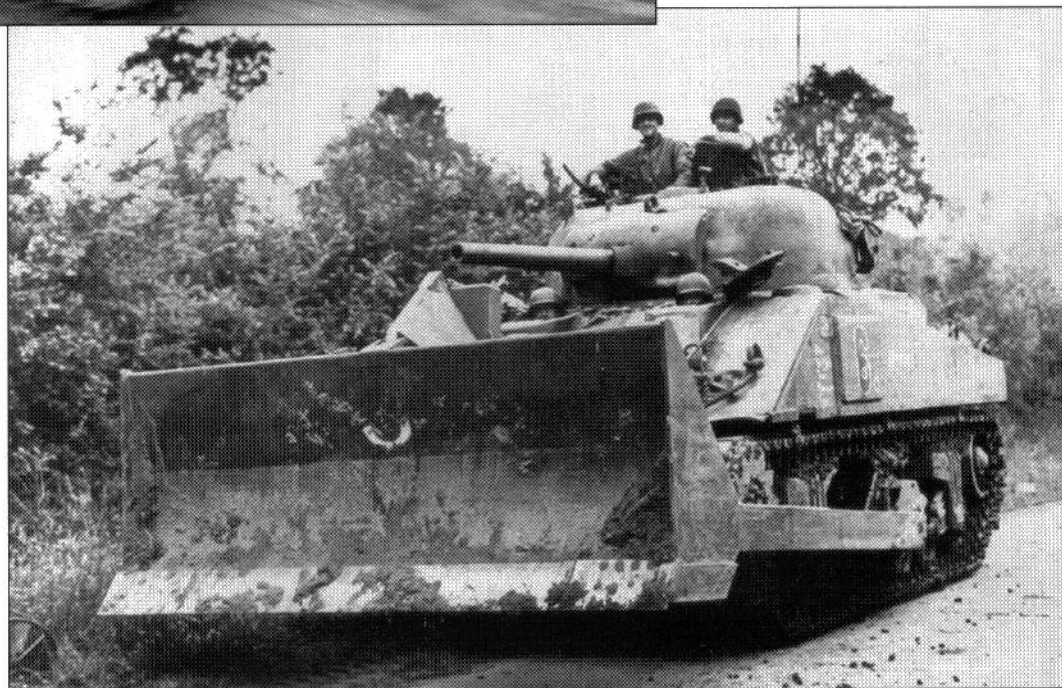
A M4 dozer tank named "Apache" of Company A, 70th Tank Battalion in the area beyond Utah beach in June 1944. The M1 bulldozer kit was one of the few US Army engineering innovations used at Normandy. Besides proving useful in the invasion itself, the dozer tanks proved invaluable in the bocage fighting to help clear lanes through the thick hedgerows. (US Army)

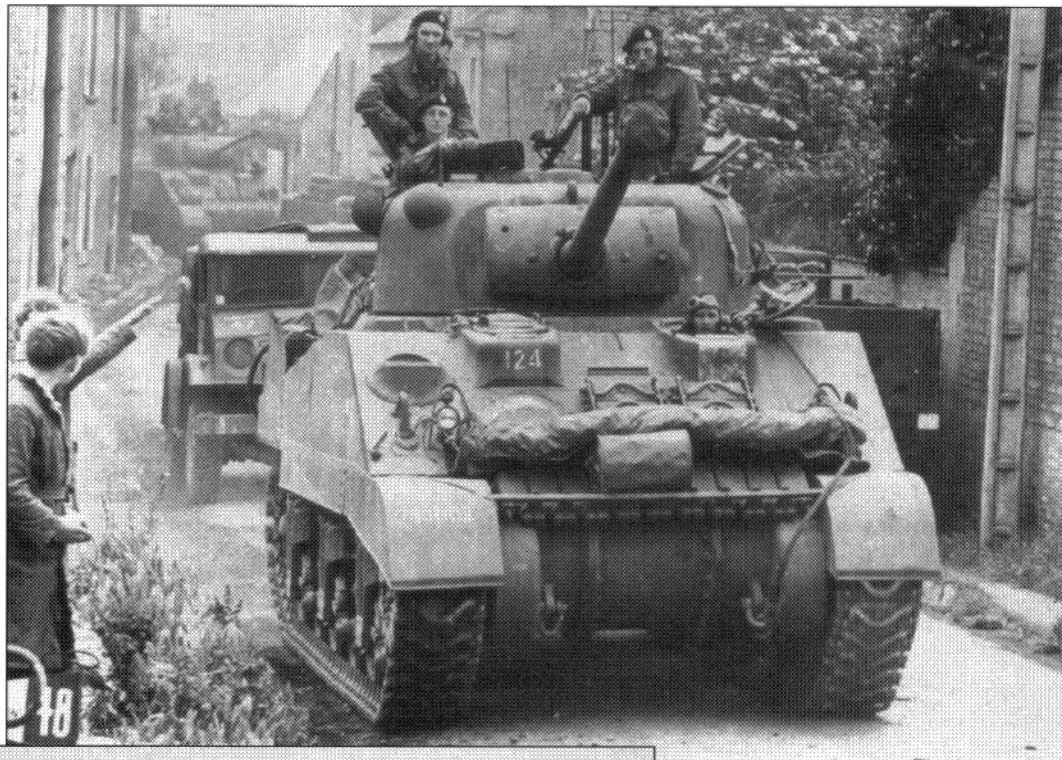
A Sherman Vc Firefly of the 4 RTR passes through a French village on 8 June. The tactical sign, a white 124 on a red square, was the characteristic numbering of a tank in an independent brigade rather than in one of the divisional armoured brigades. This photo clearly illustrates one of the other important changes made on the Firefly: the addition of a turret roof hatch for the loader. (The Tank Museum)
